RIPARAZIONE CAMBIO R1150GS

Dal forum http://www.advrider.com/forums/forumdisplay.php?f=50

bemiiten 26/11/2006 R1150GS 2000

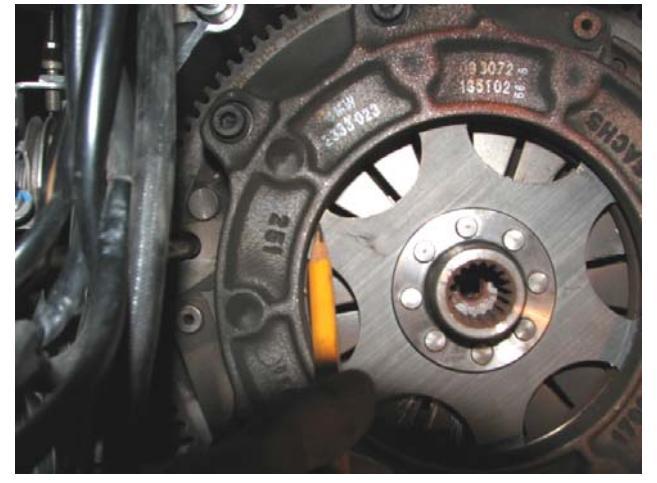
Not so sure about this one. Manual shows a wear limit of 4.8mm, this one measures 6.3mm.

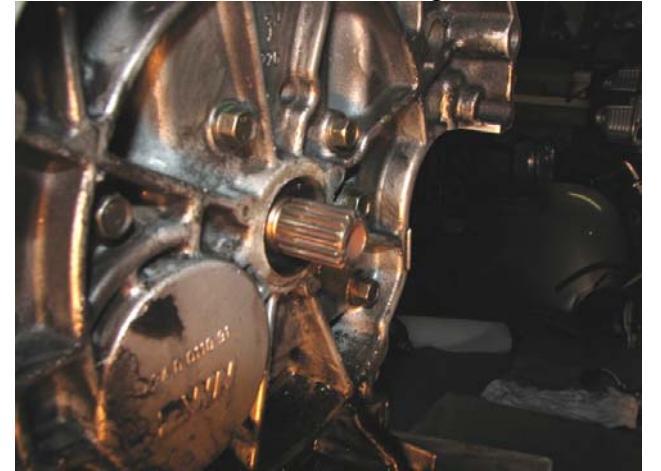
The trans input shaft.

The trans input seal on the other hand...

Looks to me like you may have the input shaft spline problem. Your clutch disc splines look worn out, and the input shaft appears to have a lot of taper. Did you have problems shifting?

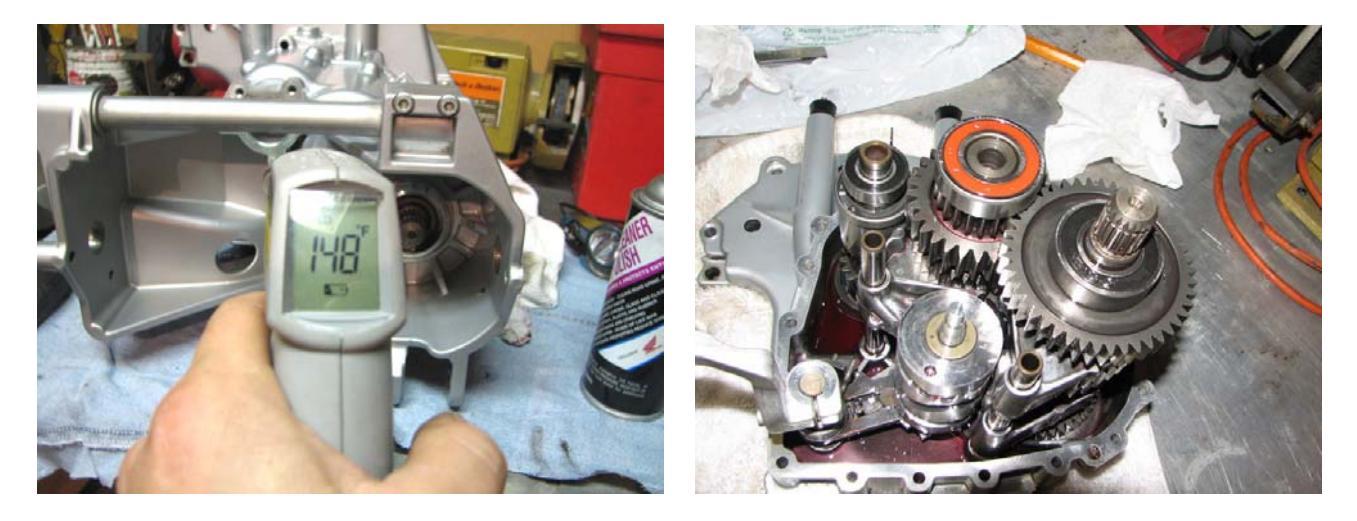
This **laser temp reader** takes out the guesswork. After about 30 minuets I'm reading 170°F (75°C). I decide to give it a try. The back half of the trans slips off easily by hand. Sweet!

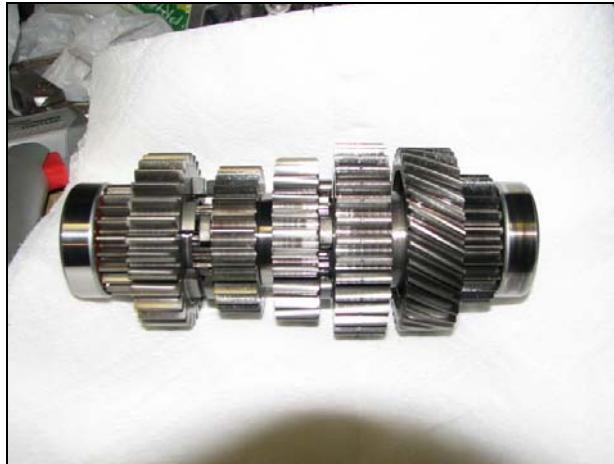
Intermediate shaft (7 gears)

I am relieved to see the intermediate bearing clearly looks and feels completely buggered. No doubt , This is the culprit!

All three front bearings show signs of discoloration, but only the intermediate feels bad.

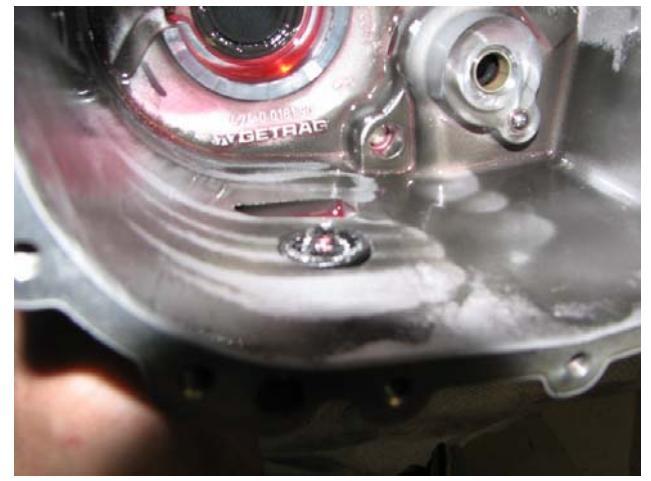
Here is a picture after I cleaned the trans plug once already. I rode the bike less than a mile and managed to pic up this much more debris!!!

You can bet that this will be coming out at every service from now on!

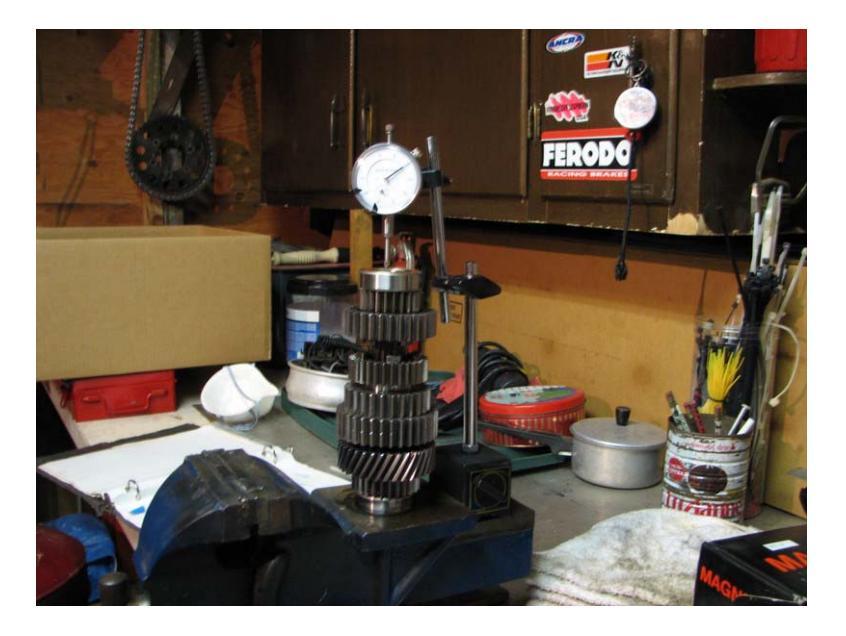
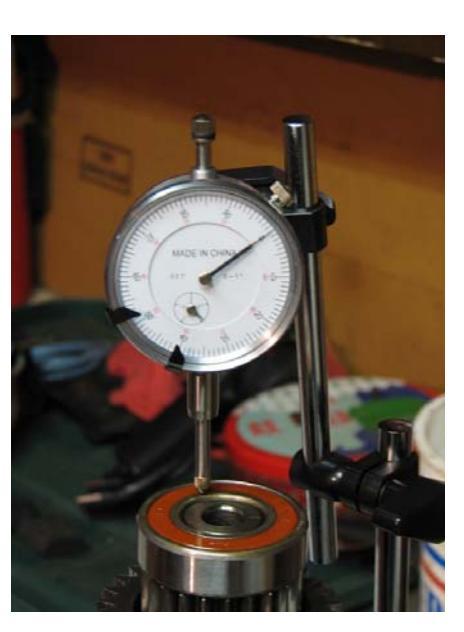
I set up a dial indicator to measure the overall length of the assembled intermediate shaft. I get repeatable results with this method. I also used a digital caliper to measure overall length, but found the results to be too varied to fully trust.

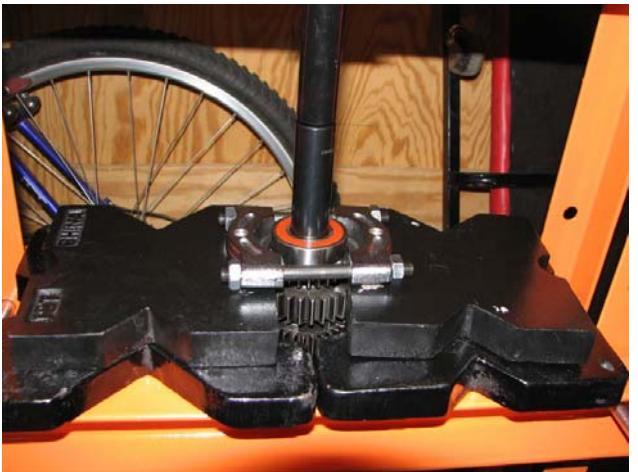
The freezing and heating paid off when the bearing came off nicely without excessive force.

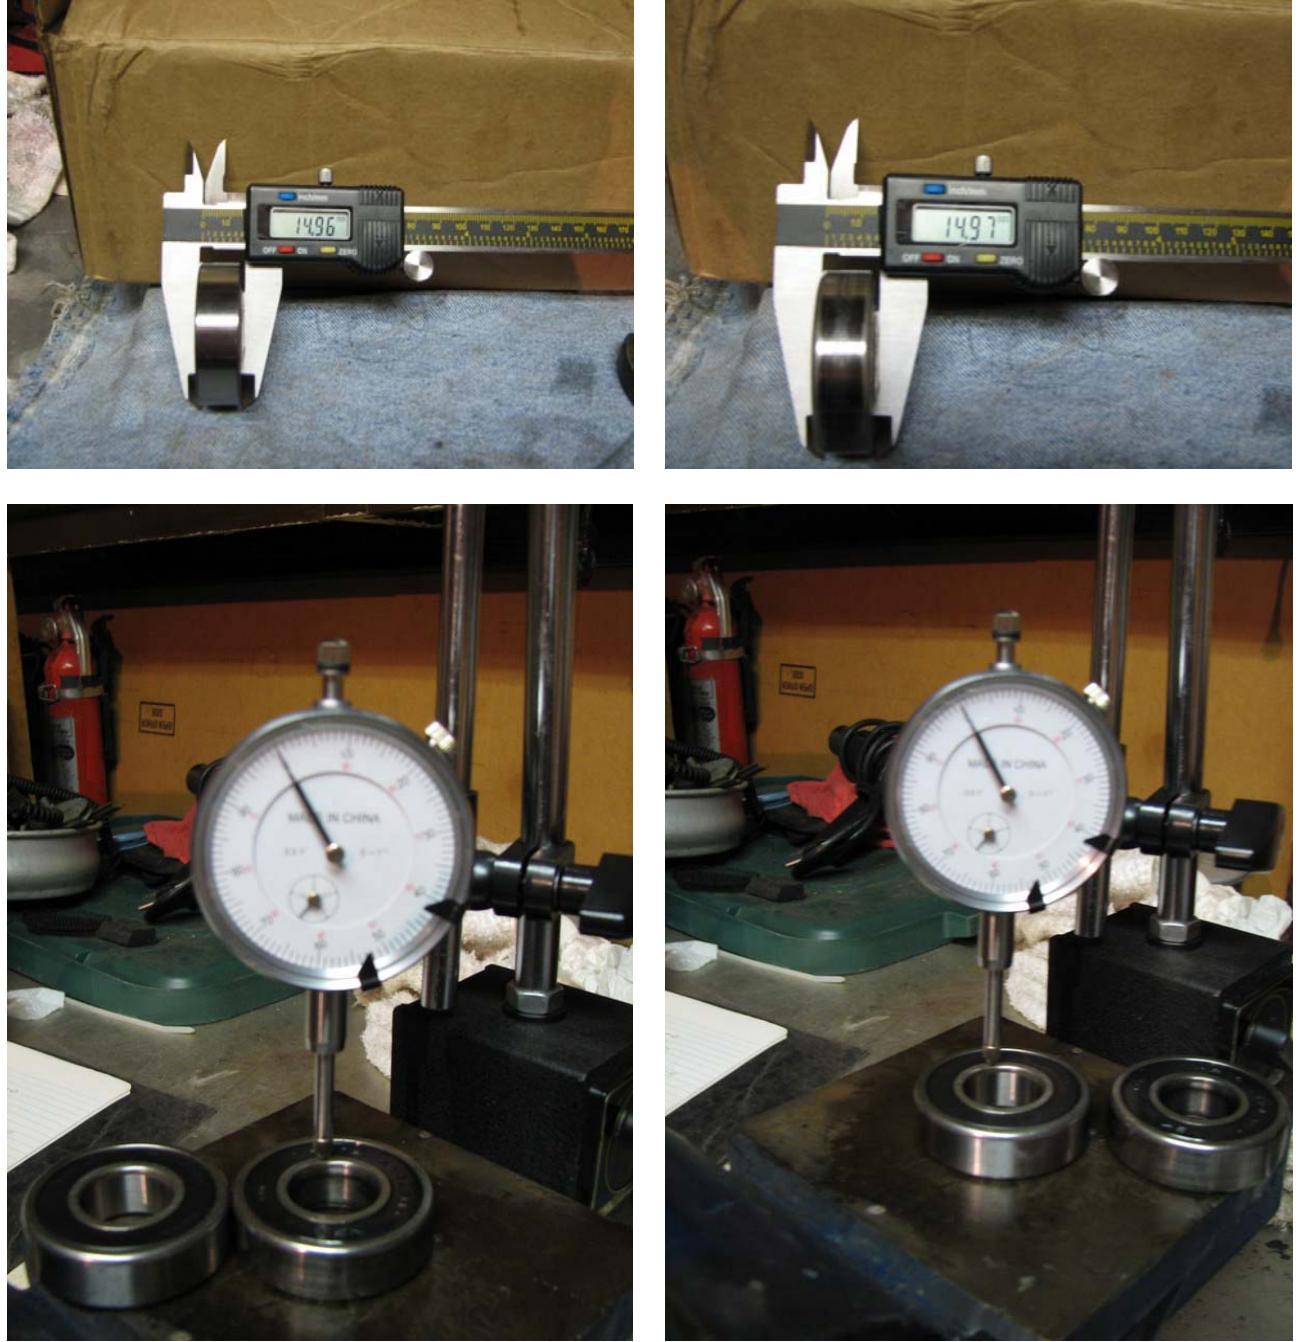
The original failed intermediate bearings are from Japan. The replacements are from Poland (same part#). The original output shaft bearings are from England, the replacements are also from Poland (updated part#).

All the bearings new and old measure the exact same thickness.

Old bearing

New bearing

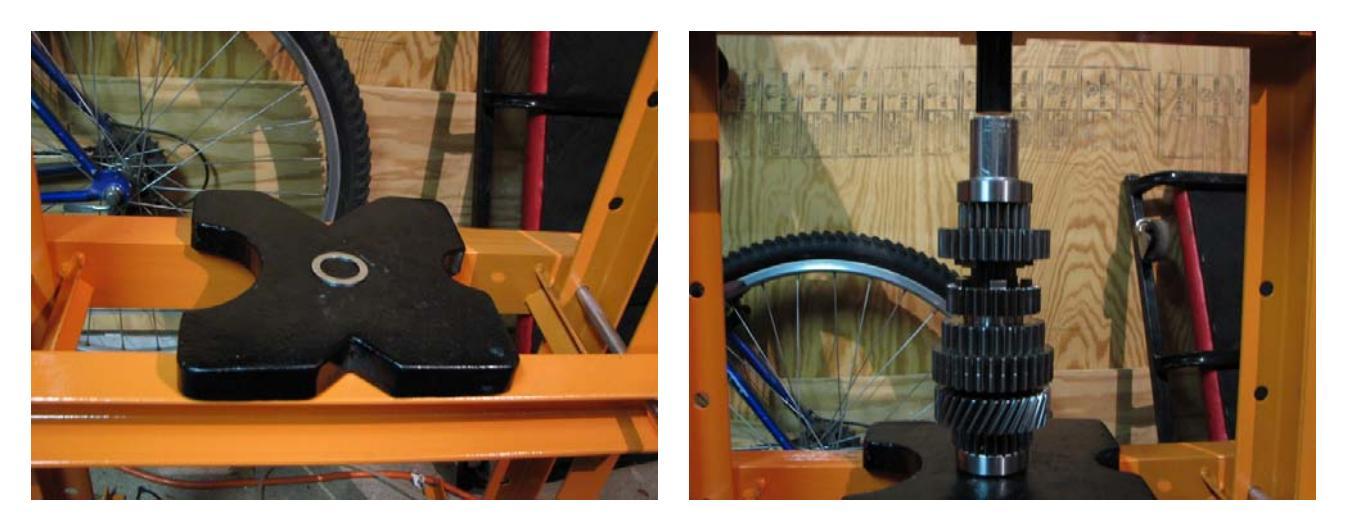
Here is the procedure I used for installing the bearings. I start by using a washer to absolutely guarantee that no force is exerted on the outer race.

I freeze the shaft and use a heat gun on the new bearings. When the bearings hit about 150°F (65°C), I carefully line up everything in the press. It is easy to feel when the bearing is fully seated.

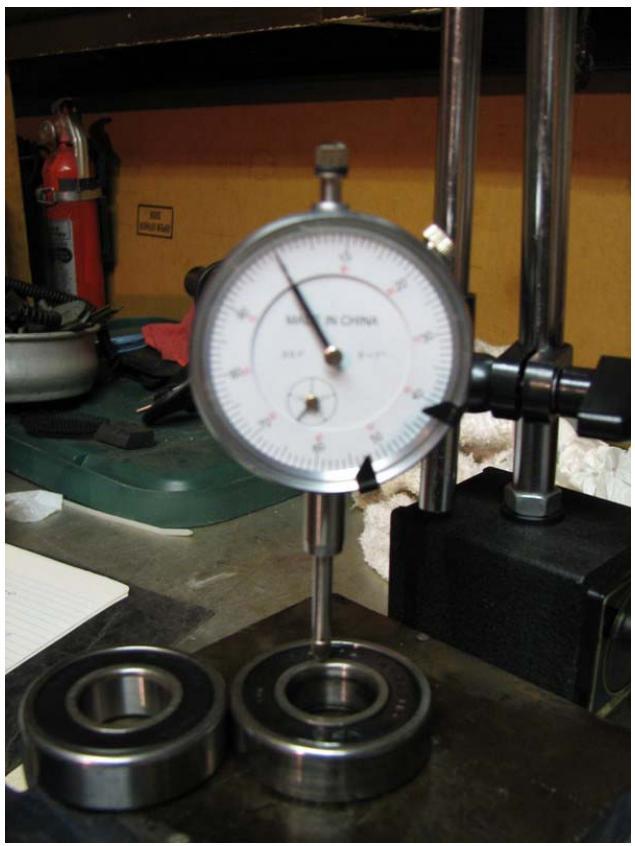
Old bearing

Like before, a comparison of old and new bearings show them to be exactly the same.

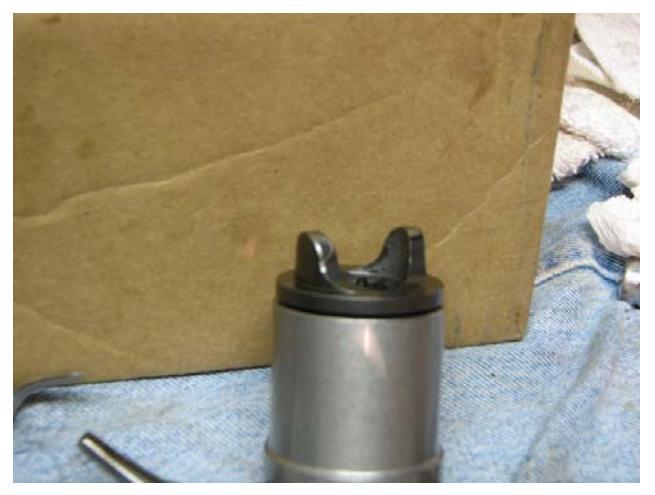
After 55k and one spline lube at 35k, the input shaft splines look like they have some life left in them.

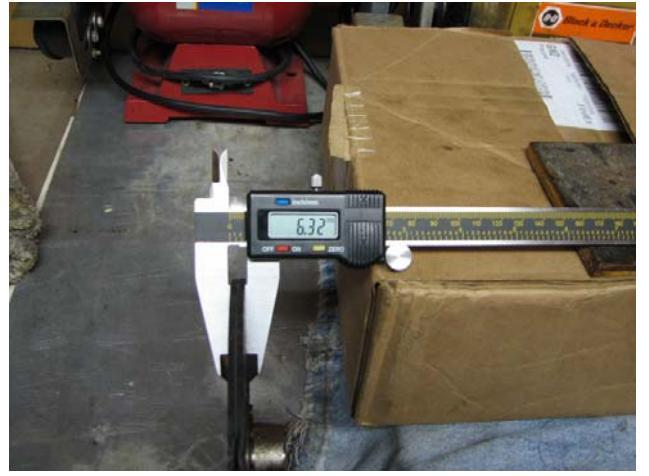
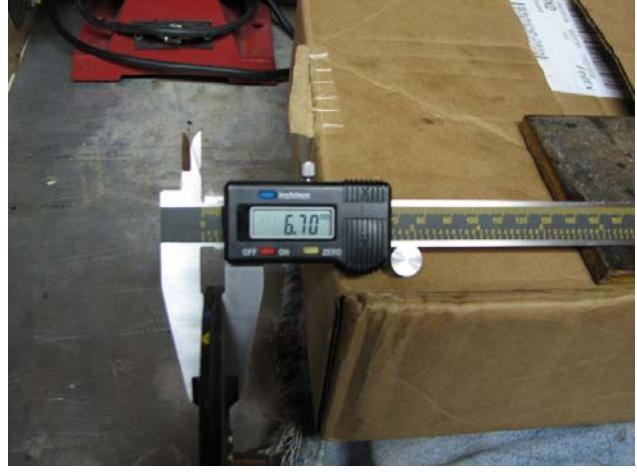
Old clutch measures 6.32 mm, new one 6.70 mm. Manual shows a wear limit of 4.8 mm.

Old disk

New disk

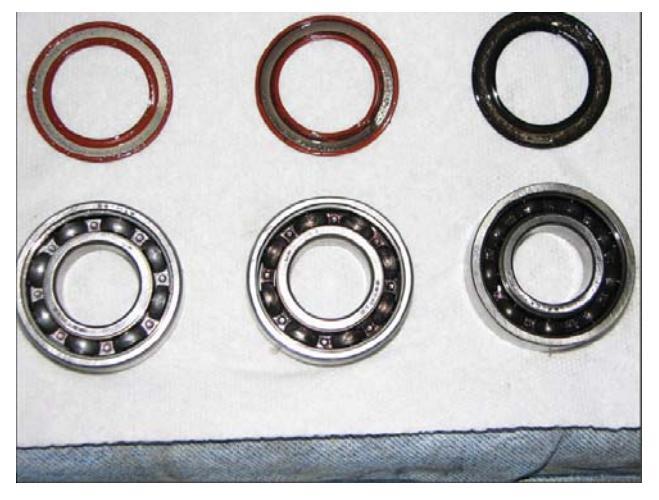
At the left is the culprit bearing. You can see that the sealed bearing is out of it's lubricant. The seal shows metal shavings from the failure.

Middle one is same (made in japan) bearing as left, also looking like it has some shavings and not much of whatever it is they pack these with. I do see what looks like, the red trans fluid on the bearing cage. Maybe the synthetic penetrates the seal and dilutes the grease?

The last on right is an output shaft bearing made in England. Looks like it has much more lubricant left then the other two

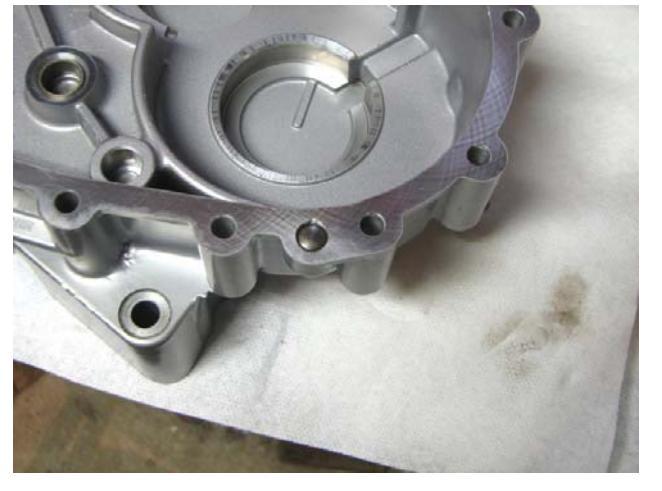
I noticed this little bite out of one of locating pin bores (ndt: fori).

The trans housing precludes setting your drift (ndt: attrezzo spina d'allineamento) for a straight shot. Had to use a smaller 3/16 (4.75 mm) drift at an angle and it resulted in this.

BMW must have an offset drift for this as I recall it didn't make sense to drive the pin from the opposite side. Anyway this picture is after I removed a small aluminum burr (ndr: truciolo).

This resulted in the punch nicking the case, visible at the top of the pin.

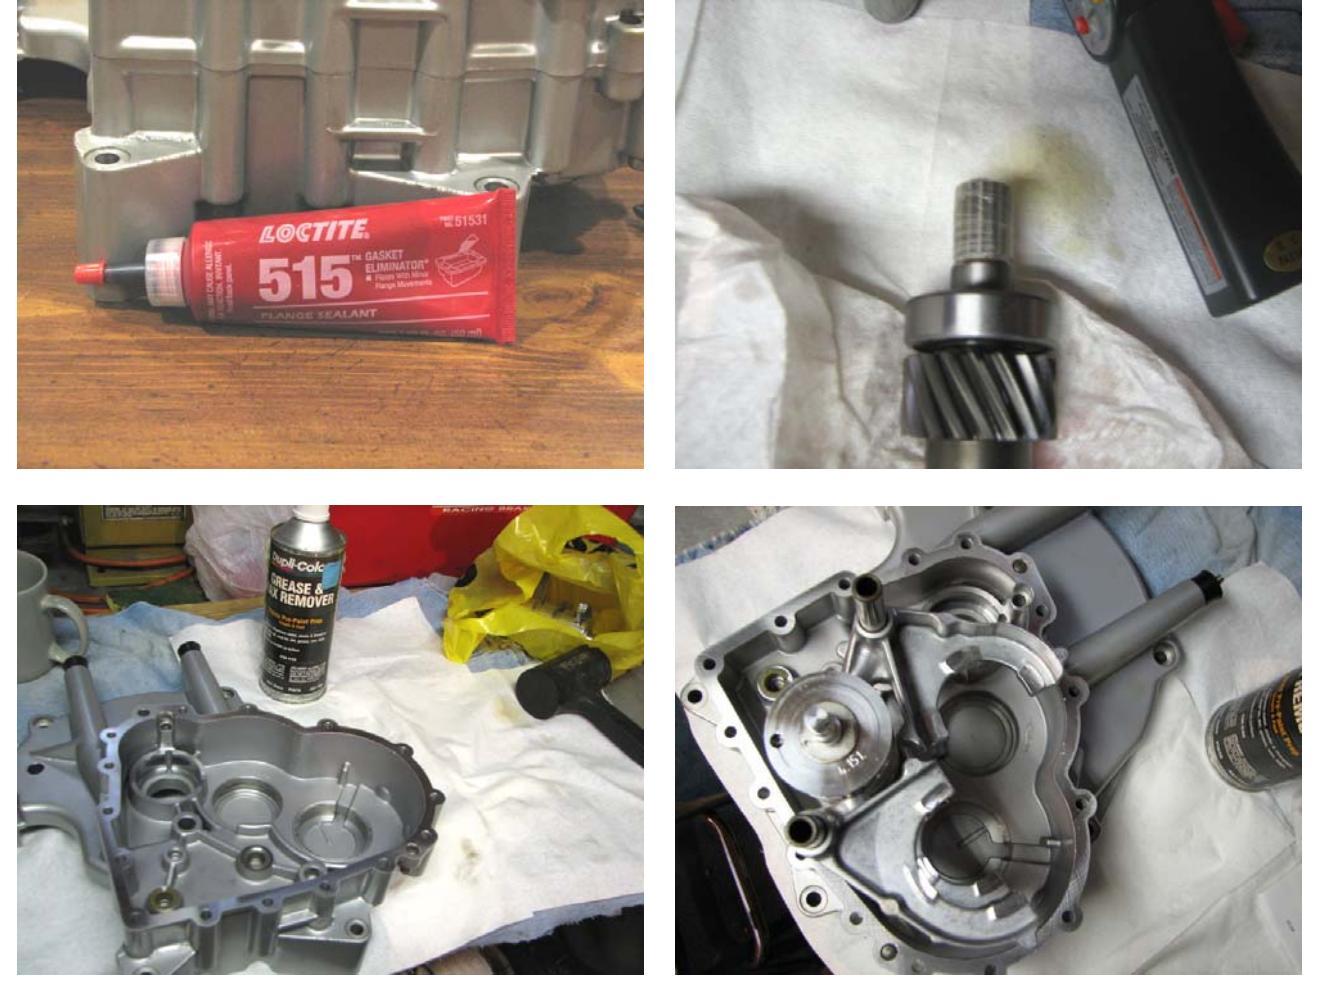
I clean the gasket surface with proper solvent and make sure I have everything oriented properly.

With the assembled transmission shafts still in the freezer, I begin to heat the front case with 2 heat guns. Getting all three shafts plus one shift fork into case all at once is a little tricky.

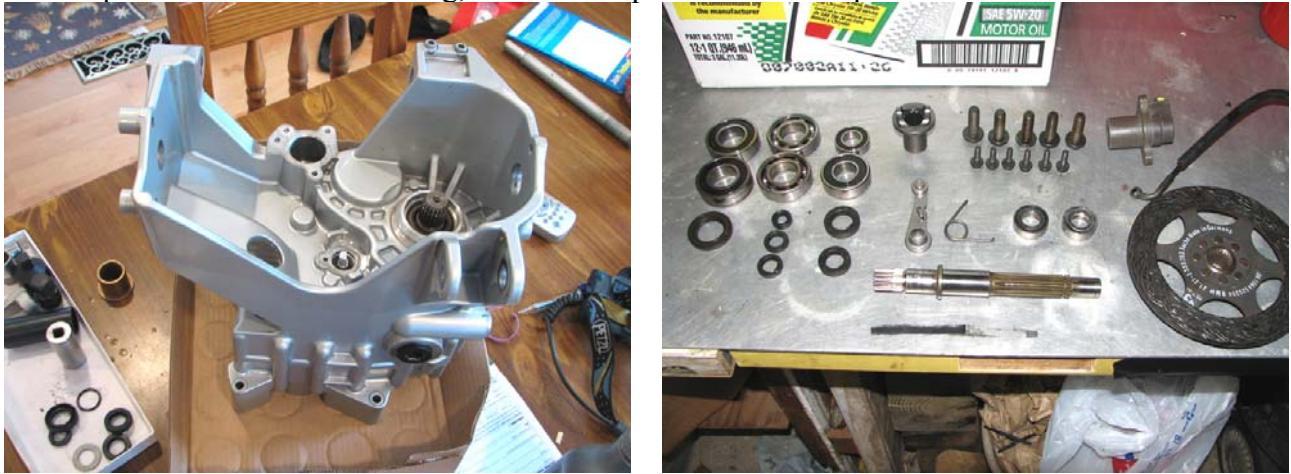
To complete the mid life refreshing, here are the parts that were replaced.

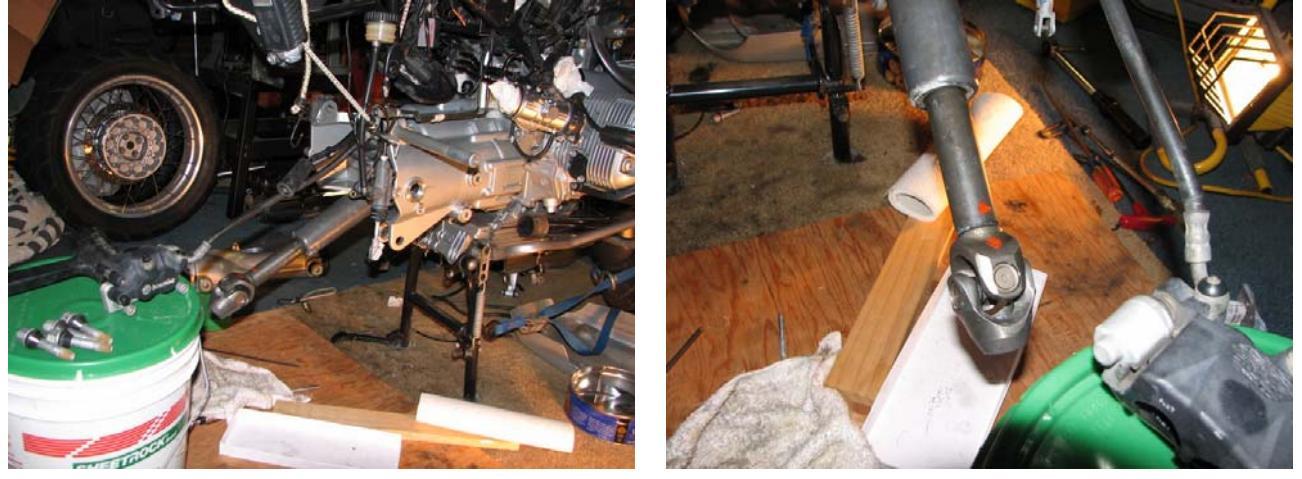
I coat the splines with Honda molly 60 a little more generously then the first spline lube because the splines looked dry again after only 20,000 miles.

I put a dot of red paint on the driveshaft to make it easier to confirm I have phased properly.

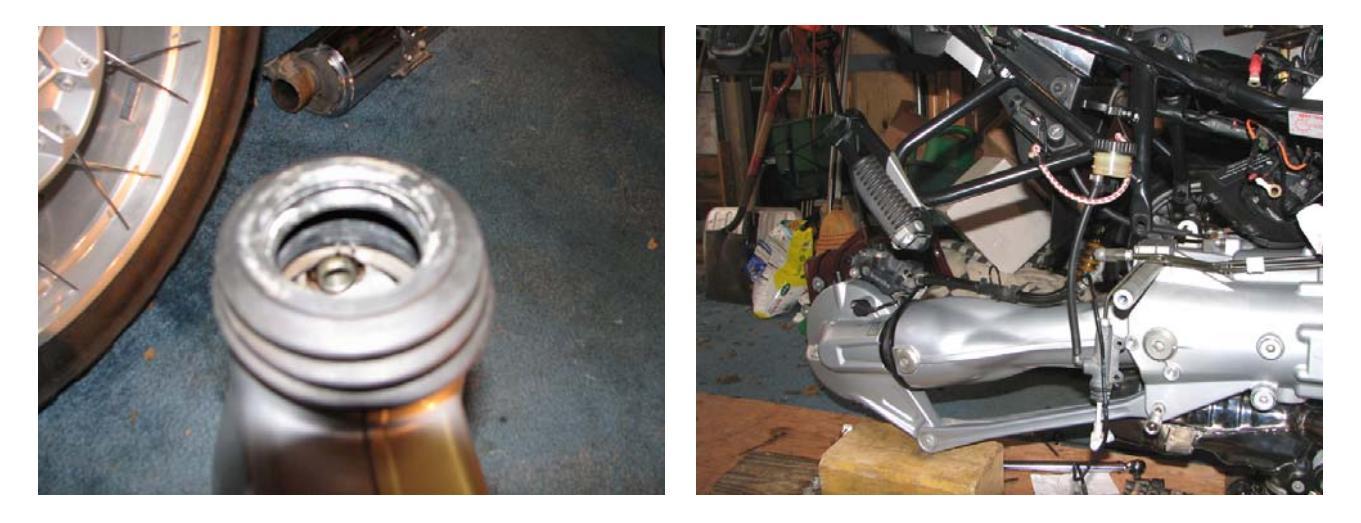
I replaced the rear Paralever pivot bearings that were overdue for replacement. The front were still good. I cheated and used blue Loctite for the stationary pivot, and nothing on the adjustment side to facilitate adjustment later if needed. An other small dot of red paint on the pivot and adjustment bolts will give me a visual confirmation that nothing is loose.

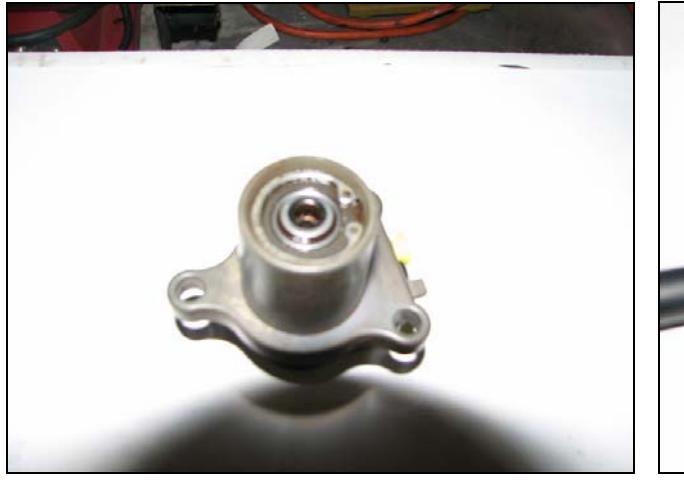
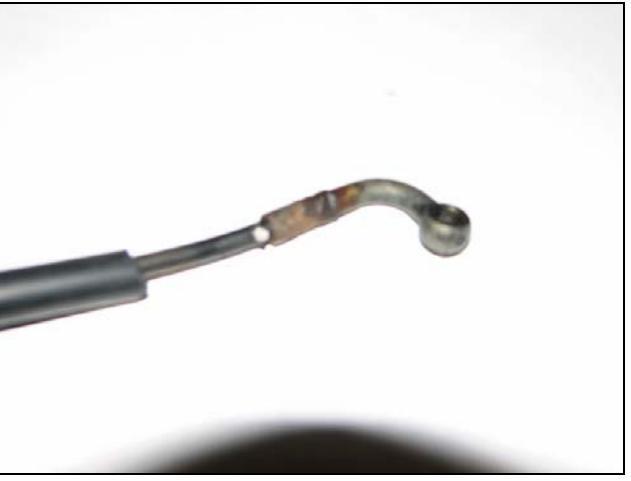
Doing some preventive maintenance, I decide to clean up some of the rust on the clutch line.
